# Vermillion River Linear Park Natural Resource Management Plan

**This Natural Area Management Plan and Work Plan has been reviewed and approved by:**

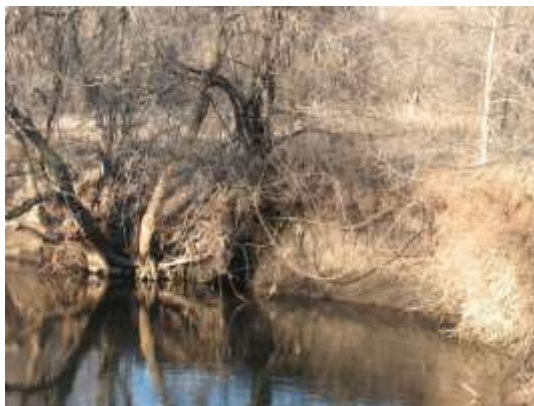
Photo 1. Steep slope with exposed bare soil (just to the right of, and behind, the trees in this photo). This is a cutbank slope, and is located in one of the bends of the river on the western side of the park.

amounts of drain tiling in agricultural fields), the banks of the Vermillion River are having a hard time maintaining their structure. In several spots, the riverbanks have eroded, and are currently eroding, quite seriously (**Photo 1**). In places, the channel is becoming quite entrenched, with several stretches of riverbank, primarily the cut-bank parts, having much active erosion, very steep banks, and scoured slope toes. Solving watershed issues and upstream issues goes beyond the scope of this report, but some stabilization recommendations are made in the section “Existing Landcover and Ecological Recommendations”.

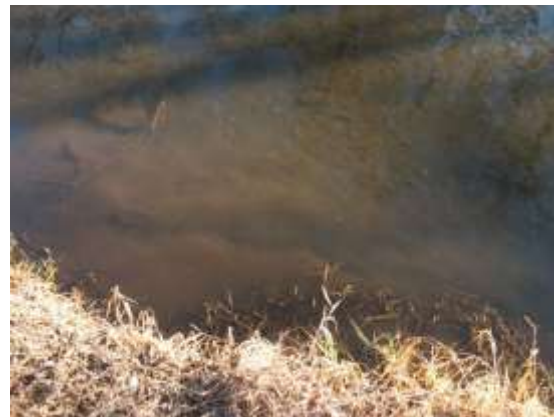
Photo 4. View of river bottom. Note the muddy plume near the shore. Also note the complete lack of vegetation on the riverbed. Reed canary grass dominates the vegetation on the steep slope in the foreground.

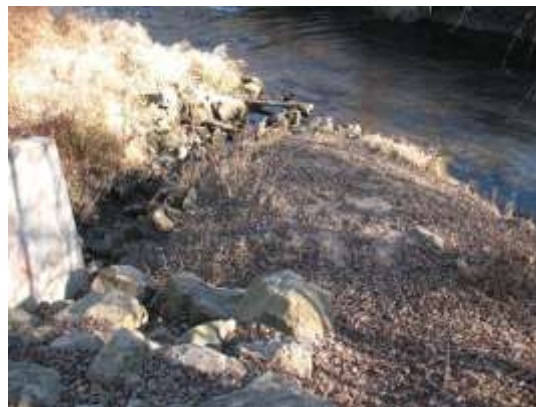
Photo 6. Stormwater inlet to river. The concrete structure is visible on the left.

river, the area to infiltrate or pre-treat stormwater is insufficient to prevent loading and high discharge rates. A potential solution, perhaps, would be to install multiple raingardens throughout the residential neighborhood. The raingarden strategy has successfully reduced stormwater discharge in other communities around the country (10,000 Raingardens Initiative, Kansas City, Missouri; Metro Blooms, Minneapolis, MN, etc.).

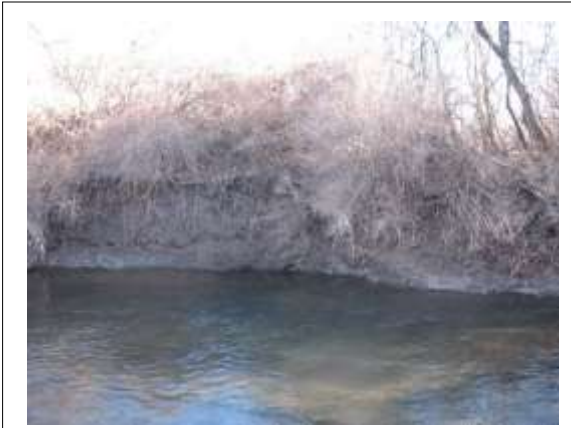
Photo 7. Gouge in riverbank opposite stormwater inlet pipe from Photo 6. Note the bare soil and band of erosion on the mid and low bank. Exotic shrubs dominate the vegetation on top of the bank.

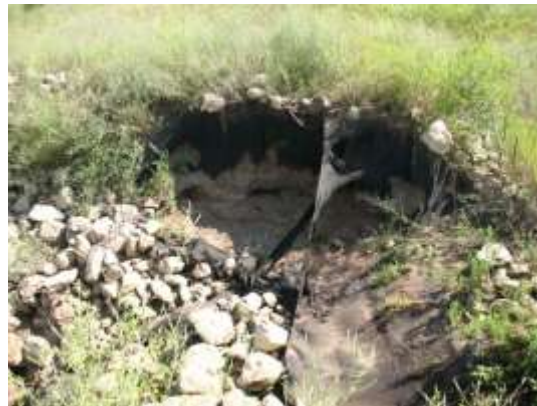
an inlet structure (**Photo 9**). Here, the liner was breached and requires repair.

Photo 9. Blowout caused by rushing water from inlet pipe on south side of stormwater pond.

Either increasing the hard armoring of this area and/or reducing the amounts and rates of flows from the pipe would be solutions to this problem. Reducing flow would require stormwater BMPs up the watershed, for example raingardens, rain barrels, infiltration areas, pervious pavement, etc.

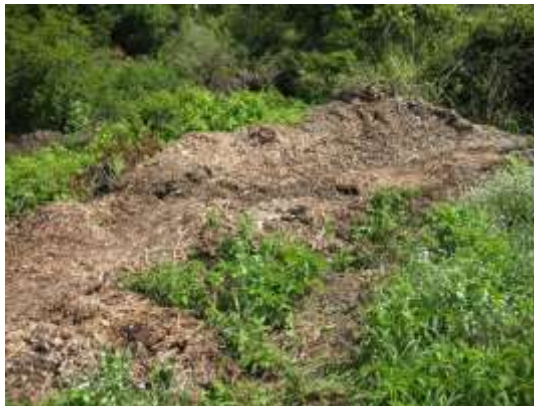
Photo 10. Chip pile on top of riverbank at southwest part of park. Note the proliferation of exotic forbs indicating disturbance.

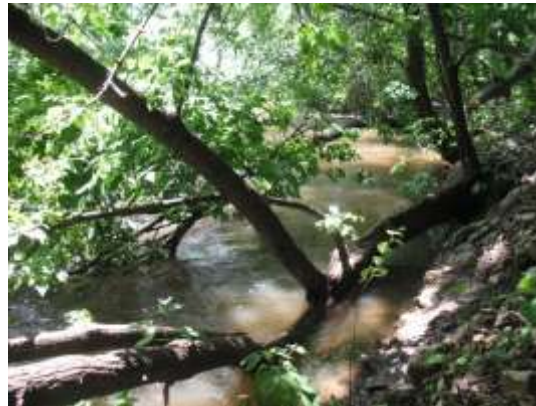
Photo 20. Note the banks of the river that are canopied with trees, but much bare soil is exposed on the right bank. Water was high at the time of this photo, in June, 2012—note how “muddy” it is.

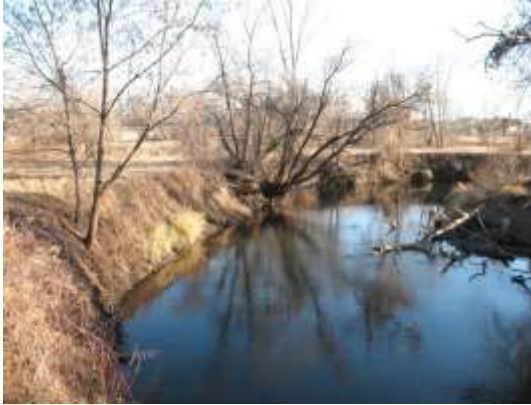
Photo 21. View of river bend at western part of property. Note the very steep slopes along the entire bank. Also note the meager amount of vegetation covering the banks—much is actually bare soil. This is the “cutbank” side of the bend.

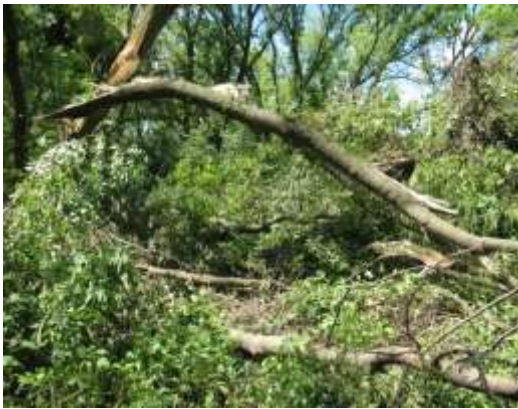
Photo 22. Damage to trees in Linear Park. This large boxelder lost several large limbs.

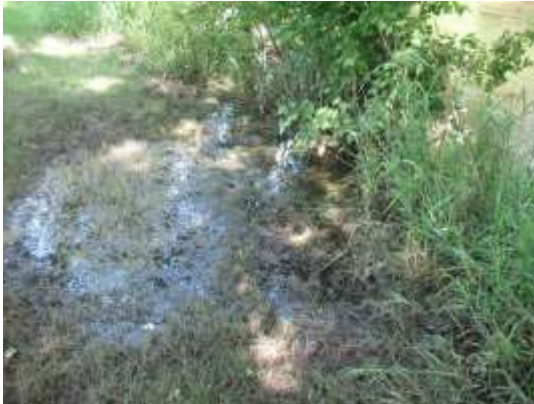
Photo 33. Flooding onto the mowed turf buffer. The area of flooding actually extended farther upland: note the brown stains on the grass from river sediment.
