# Vermillion River Linear Park Natural Resource Management Plan

**This Natural Area Management Plan and Work Plan has been reviewed and approved by:**

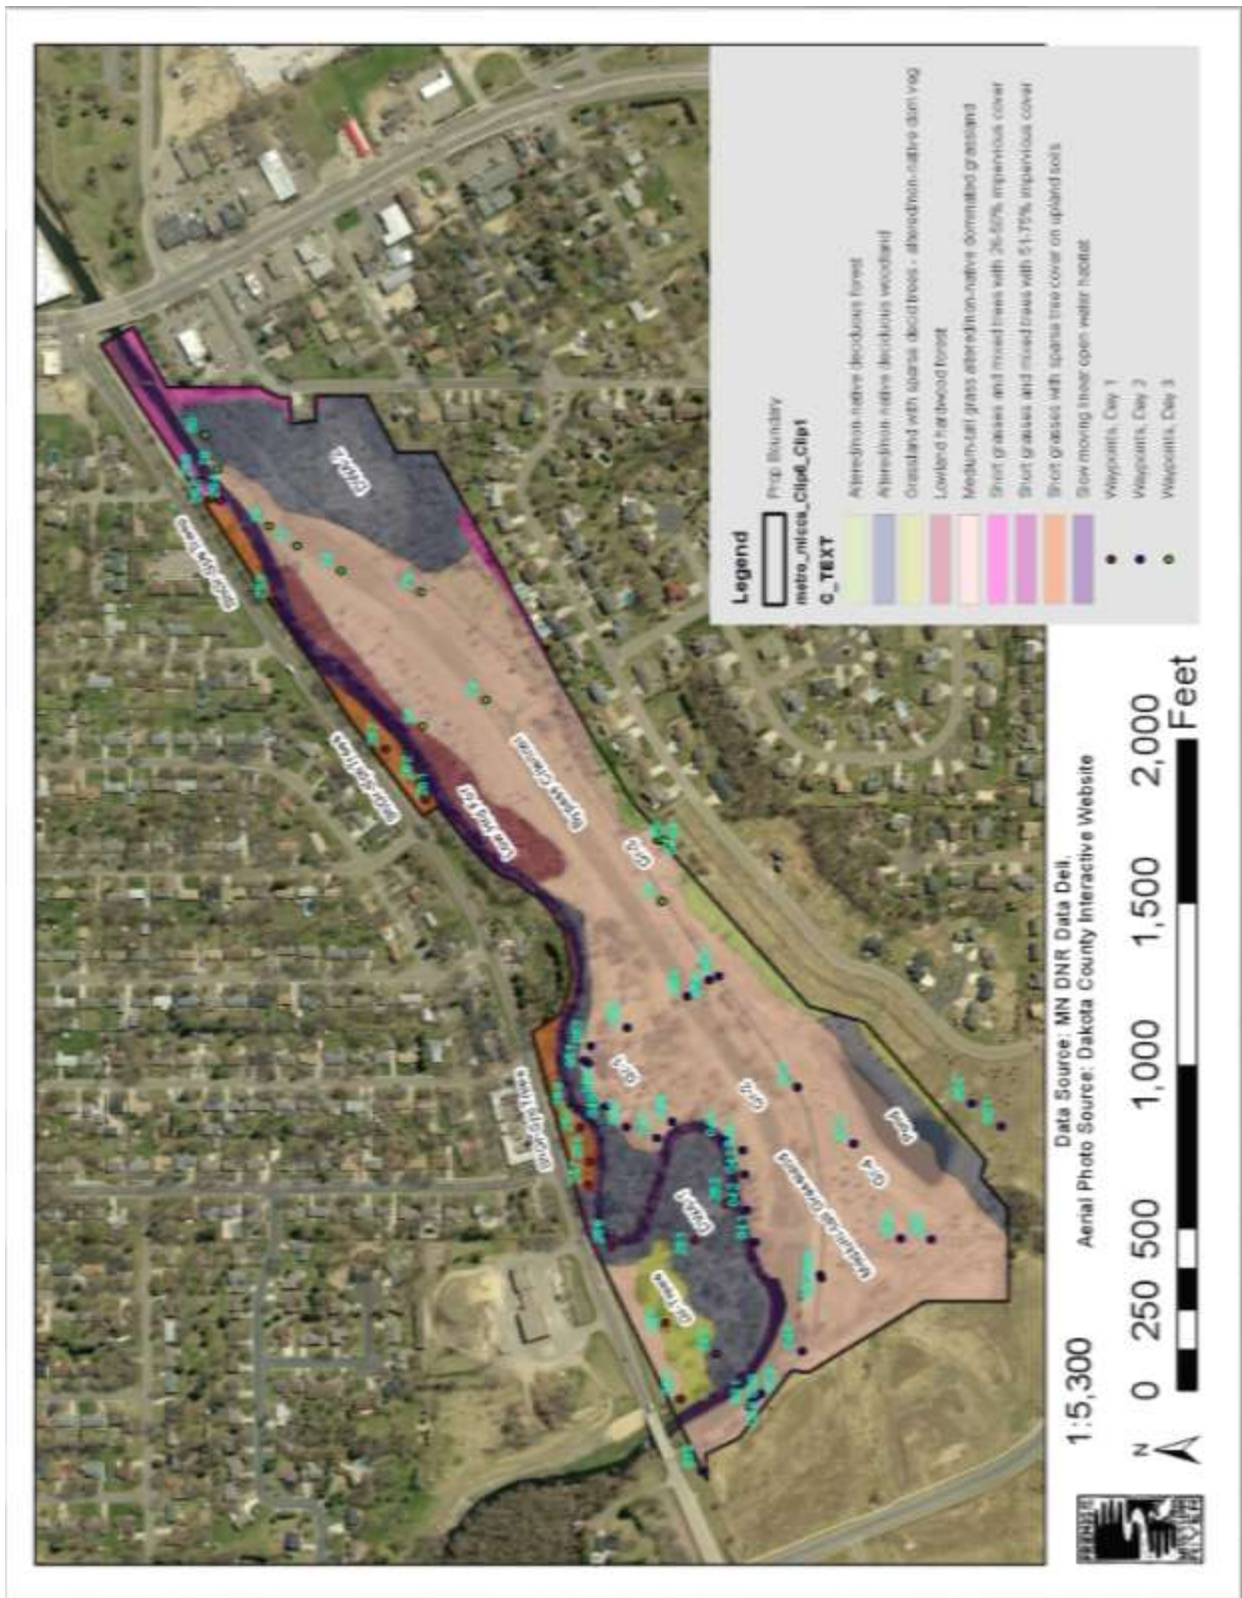
Figure 16. Existing Landcover with Waypoints

Wypt	Comment
1	Starting point. Near Marie Ct.
2	Stormwater inlet structure--hyb catts. Lots of rip-rap. Bank eroding--blowout--in one spot--photo.
3	Whorled milkweed. Photo.
4	Lots of shrubs and seedlings. photo
5	Paved trail and bench.
6	Paved trail
28	Paved trail
29	100 yds straight west: young red tail hawk in cott tree. Very lg bird. Crying almost constantly.
30	Cow vetch by trail.
31	Paved trail
39	Paved trail
40	Trailed crossed by a mowed "road". Access for city vehicles?
41	Cleared zone to river. Cott stumps, rip-rap. Brush cut veg. 5'-tall ragweed-like plant. Lots of motherwort.
42	Chip pile.
43	Another access--bare soil area to river. Tire tracks.
44	Patch of bouncing bet
45	Hack on bank: 14" dia. Lots of grp vine.
46	H5 & burdock on bank. "Bend" of river area: open, flat: sm brome, small box, cherry, elm.
47	Small patch of natives: ground cherry, cup plant, yarrow; pocket gophers--encroached upon on all sides.

79	Scour in overflow channel; alyssum, pickerel weed (?), RCG, sting nettle
80	Jewel weed in amongst rip rap
81	33-50 was edge if mow line. 52 is cup plant: many flowers, nipped off by deer-by bank
82	Patch of natives--other side of trail: flower spurge, bush clover, pr rose, ? grass
251	Clearing in floodplain. Someone is mowing the burdock. Lots of burdock here.
252	At river bank.
253	West end. Boxelders dominant here. 1 cott. A few ash and willow.
254	3 river birch--they have no wind damage!
255	Middle of open, mowed field: sm brome, scattered box & cott; gopher mounds! History of this area? Restore to mesic prairie.
256	River bend
257	Big cott near pk lot. Erosion on cut bank here.
258	By pk lot--swirl pool at bank--eroding--steep.
259	Concrete "box". Culvert?
260	Alluvial terrace--or "rill-bank". Could control exotic grasses & burdock. Replant w natives and would be nice.
261	Concrete "gate".
262	Disturbed. Can thistle, bindweed

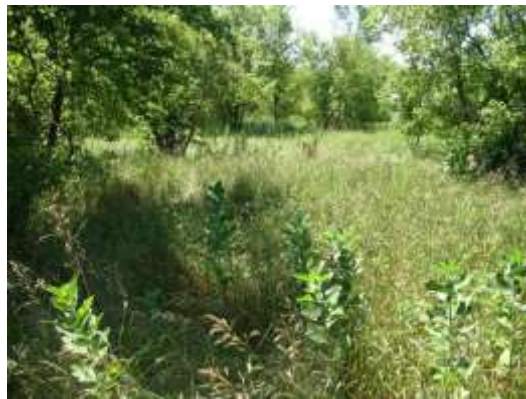
The upland side of this sub-unit was a former pasture, as evidenced by the dominance of smooth brome grass (**Photo 11**). Scattered throughout this area were many small to medium-sized (3" to 10" diameter) boxelder trees that had invaded within the last 20 to 30 years. Also present here were non-native invasive species such as bull thistle (non-native), and curly dock as well as desirable, though moderately invasive species such as common milkweed,

Photo 11. View of Gr-1. Note the Scattered trees and matrix of grassland dominated by smooth brome. The tall forbs are common milkweed.

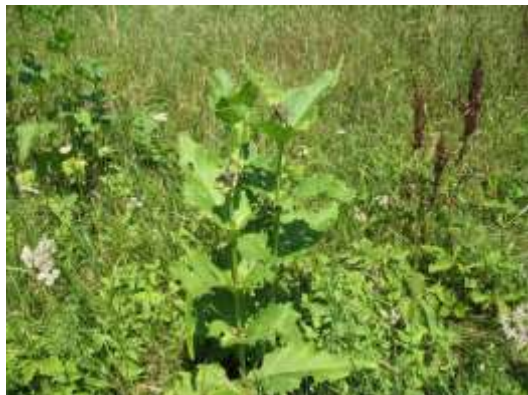
Photo 12. Small remnant of native vegetation in Gr-1. Cup plant is the taller forb in the middle. Smaller forbs also include ground cherry, yarrow, and whorled milkweed. Exotic, invasive weeds were invading: curly dock is the reddish forb on the right.

remnant of native plants, including ground cherry, cup plant, yarrow, and with many pocket gopher mounds (**Photo 12**). Unfortunately, this little remnant was being encroached on all sides by disturbed areas with many invasive, exotic plants. This little remnant should be preserved and expanded into the rest of the surrounding area, if possible.

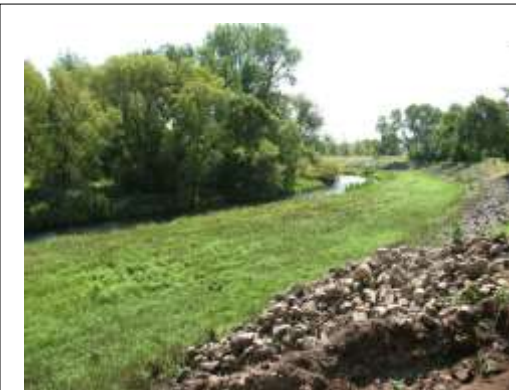
The northeast end of Gr-1 was mowed right up to the water's edge (**Photo 13**). At the turn of the first bend, riprap had been installed not only on the banks,

Photo 13. West end of property, west of river bend. Note the mowed vegetation near the river and the riprapped bank.

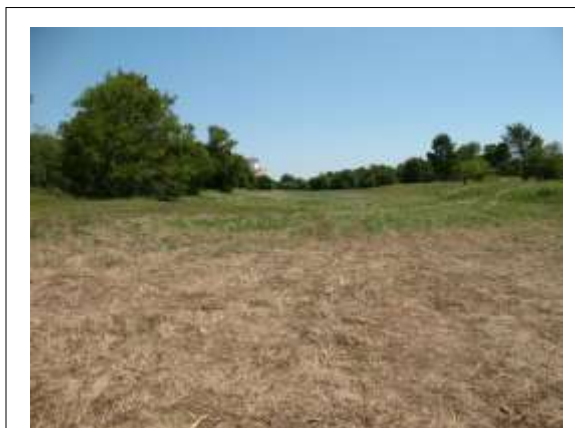
Photo 14. Bypass Channel looking eastward. River is on the left, with Lowland Hardwood Forest unit (trees on left). Note the broad, shallow swale dominated by short grasses with some forbs. Con Agra tower can be seen in the background.

Gr-2 subunit was the mowed swale of the Bypass Channel (**Photo 14**). This includes the sides of the swale and the bottom of the swale. It was also a long, linear area that traverses most of the property. Both the sides and the bottom of the swale were dominated by grasses. Both native and non-native grasses were present, mixed together. Purple love grass (native) was abundant, and porcupine grass (native) was rare. Also present were the non-native grasses green foxtail, Kentucky bluegrass, quack grass (in abundance). Forbs were both scattered and found in large patches. The native forb whorled milkweed (*Asclepias verticillata*) formed

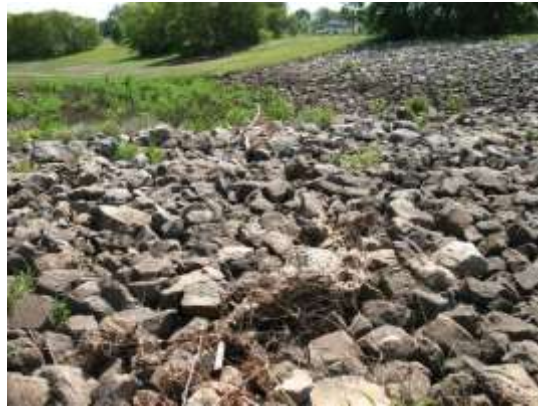
The westernmost end of Gr-2 consisted of a very heavily rip-rapped east-facing slope (Photos 13 and 15) and the western end of the paved trail. To the east of this, the Bypass Channel opened up into a long (4,300 feet), broad (100-150 feet), shallow swale (6-8 feet deep) covered by non-native grassland dominated vegetation (Photo 14).

Photo 15. Extensive field of riprap on swale side-slopes at western end of park.

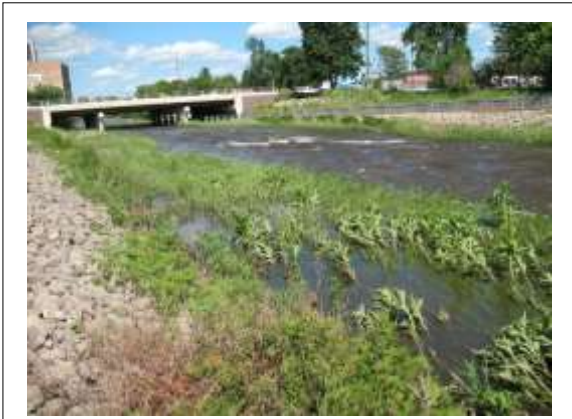
Photo 16. View looking east towards Hwy 61 bridge. Note the riprap on both sides of the channel. Vegetation is a mix of native and non-native (cup plant in middle foreground and reed canary grass in background).

(Photo 16). The MLCCS cover types were listed as *Short grasses and mixed trees with 26-75% impervious cover*, but will be included in this discussion. The north side was more infested with herbaceous weeds than the other part of the unit. Weeds were dominated by reed canary grass, but also present were patches of Canada thistle, hoary alyssum, and stinging nettle. The south side had a dense growth of jewelweed, a native wetland forb.

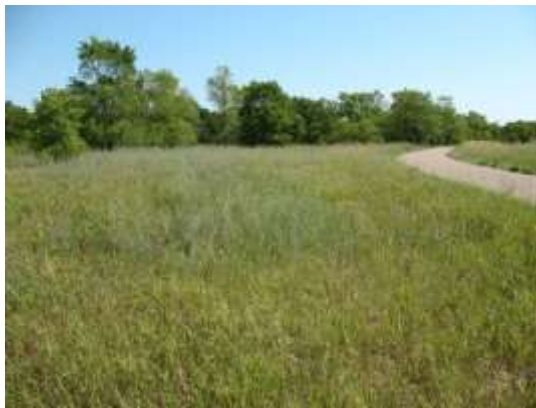
Photo 17. View of Gr-3 showing the grassland in the foreground, a grove of medium sized trees in the background and the paved trail on the right.

Gr-3 was that part of the grassland cover type that borders the swale of the Bypass Channel to the south, and is along the southern edge of the property (**Photo 17**). Again, this was a long, linear sub-unit that traverses the entire length of the southern part of the property. This portion of the unit located on the south side of the paved trail appeared to have escaped much of the disturbance caused by construction of the Bypass Channel. Included in this discussion are two small, narrow MLCCS cover type units at the south boundary: “Altered/non-native

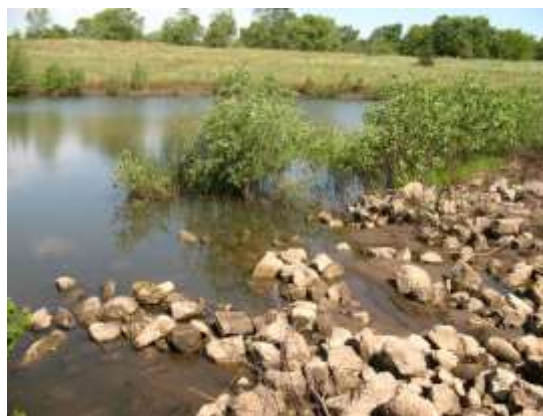
Photo 18. View of vegetation around pond. Dry, non-native grassland in the background, and some native emergents in the foreground: bulrush, sandbar willow, and cottonwood seedlings.

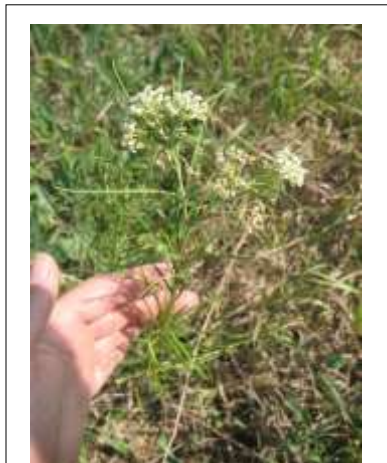
Photo 19. Close up of whorled milkweed, *Asclepias verticillata* from Gr-4.

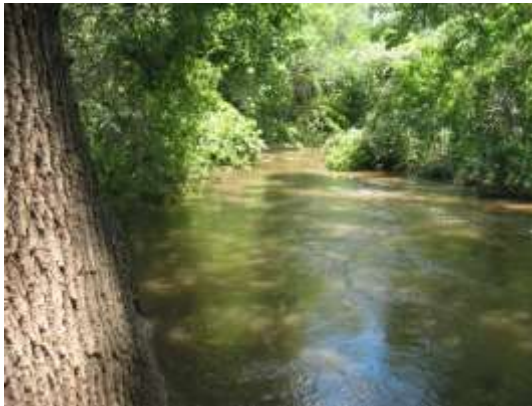
Photo 20. View of Riparian Forest at Linear Park in June, 2012. Canopy coverage is mixed: sometimes it completely covers the channel and sometimes it does not. In this photo a mix of sun and shade fall on the water.

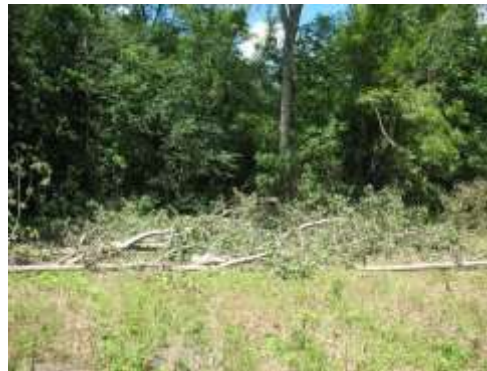
Photo 23. Beginnings of a brush pile, in cleared areas of the Riparian Forest and Deciduous Woodland, which was stacked by city crews after a storm.

use by heavy equipment. These areas were being used as temporary storage for storm-damaged trees that had been removed from nearby (**Photo 23**). Where the soil was not compacted, in its unaltered state, it was quite loose, underscoring its recent deposition. Much of the soil, however, was compacted from heavy equipment.

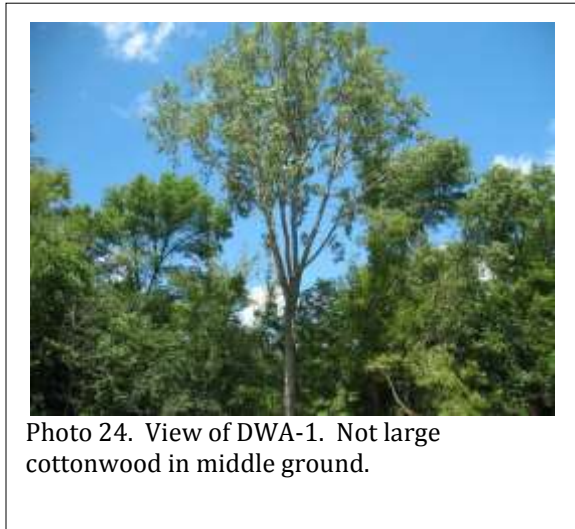
Photo 24. View of DWA-1. Not large cottonwood in middle ground.

This sub-unit can be described as a mix of open and closed canopy, with scattered, tall trees (cottonwood, boxelder, silver maple) that punctuated a matrix of herbaceous ground cover (**Photo 24**). There were scattered shrubs too. Snags (dead standing tall stumps) were present also. The ground layer was dominated by forbs, primarily non-native ones. There were extensive areas that had been cleared of trees (**Photo 25**). In these cleared areas, burdock was dominant. Wood nettle was abundant in patches. Areas that had been cleared showed evidence of

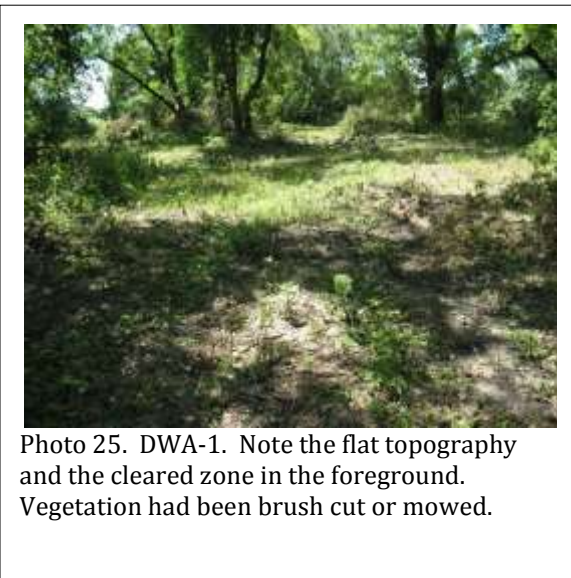
Photo 25. DWA-1. Note the flat topography and the cleared zone in the foreground. Vegetation had been brush cut or mowed.

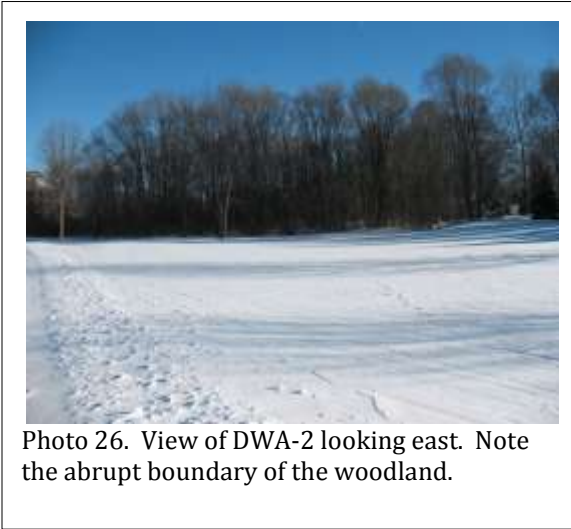
Photo 26. View of DWA-2 looking east. Note the abrupt boundary of the woodland.

The woodland had a rather abrupt boundary with the grassland unit on the west side of the unit (**Photo 26**). On the east and south side it borders a residential street. The north side is bounded by the trail. The east half of the unit (**Photo 27**) is more open than the west half, which has a fairly closed canopy (**Photo 28**).

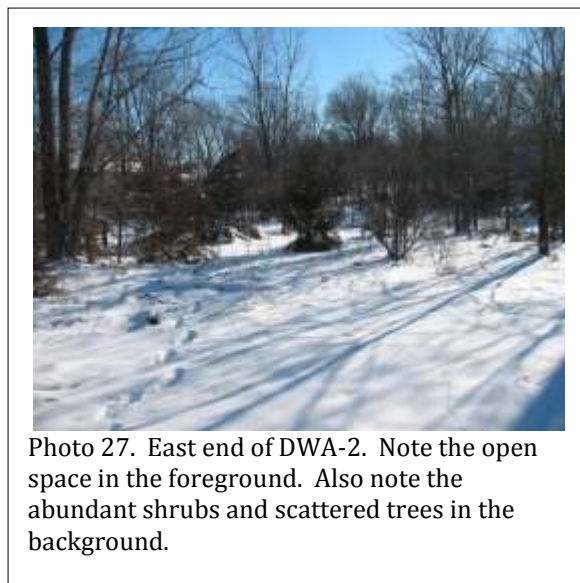
Photo 27. East end of DWA-2. Note the open space in the foreground. Also note the abundant shrubs and scattered trees in the background.

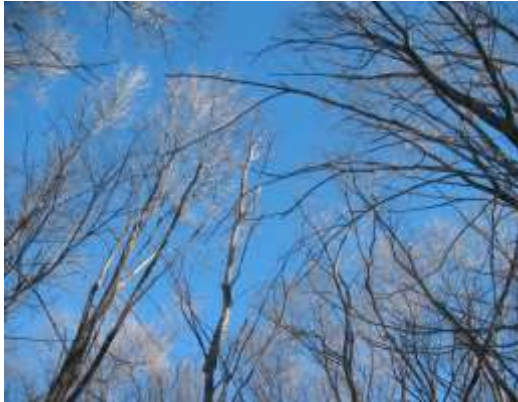
soil units (**Figure 4**). This woodland sub-unit is in the early to middle stages of succession, being composed of very recent woody invaders—trees range in diameter from 3 to 12”, with the average of 8”. The trees are very tightly assembled, with a spacing from 1 to 8 feet. The great majority are Siberian elms (*Ulmus pumila*)—an invasive exotic species—about 70% of all trees. Most of these Siberian elms were quite tall, being about 45’ tall. The next most populous tree species was cottonwood (10%), which had several 45’ tall specimens also. The remaining tree species, which rounded out the total, were redcedar, green ash, boxelder, black cherry, black walnut, Amur maple, and pin oak. The understory was dominated by buckthorn and honeysuckle, with an interrupted ground layer of Virginia stick seed (aggressive native), common yarrow (native of disturbed areas), motherwort (exotic weed), smooth brome, Canada goldenrod (aggressive native), and a few asters (desirable native).

Photo 28. DWA-2 showing the fairly closed canopy. Note the upright stature of the trees, indicating that they grew up crowded and competing for light.

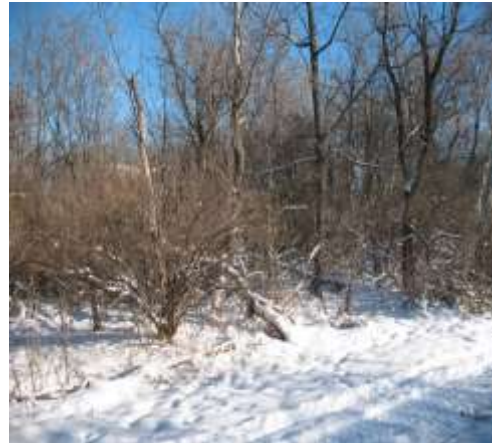
Photo 29. Little boxelder woodland in December, 2012. Note the prolific growth of exotic shrubs and the young age of the

On the farthest eastern end, across the north side of the trail (near the Appleby's), a little woodland occurred that was distinct from the larger Siberian elm woodland that was adjacent to the south of the trail (**Photo 28**). This little woodland was comprised primarily of boxelder, with an understory of Tartarian honeysuckle and buckthorn. Although it is still not a desirable type of woodland, it was not dominated by Siberian elm, which is an exotic.

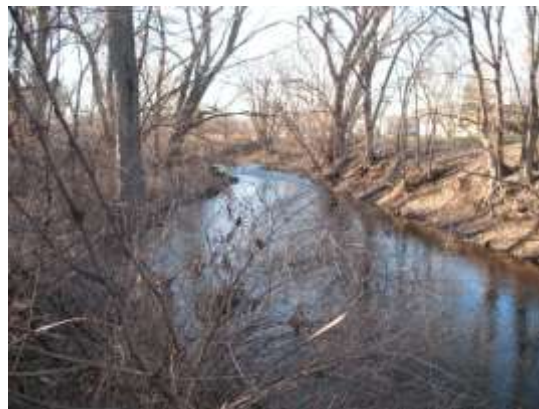
This unit is really an extension of the Floodplain/riparian forest that was described in the Deciduous Woodland-Altered (DWA-1) cover unit section, above. The only difference is that the “lowland hardwood forest” is a little bit wider than the rest of the Riparian Forest. Vegetation layers were the same as in the Riparian forest, and so are species composition, structure, and age class distribution (**Photo 30**). Shrub and ground layers were primarily the same, also.

Photo 30. The “lowland hardwood forest” is on the left and the “riparian forest” is on the right. Note the similarity of the two.

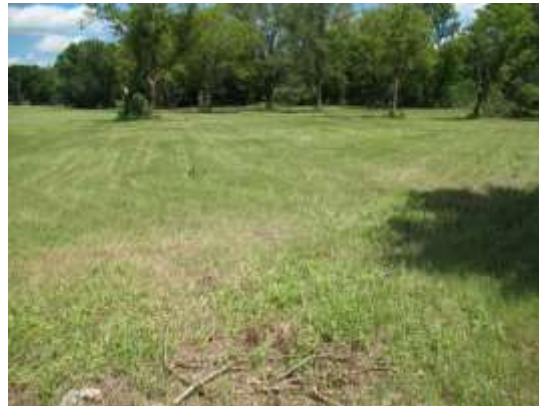
This unit was located just north of the DWA-1 unit, on Zumbro soil. It was combined with the MLCCS unit to the north, called “Medium tall grass altered”, since it was really all the same landcover type. This unit was primarily open, with scattered large boxelders and cottonwoods (**Photo 31**). This unit has been disturbed, probably formerly pastured or hayed, since smooth brome was dominant here. Many pocket gopher mounds abounded in this unit, which was a good sign. This field was currently being mowed, but could potentially be restored to mesic prairie or mesic oak savanna. On the west end of the unit were three large river birches. Notably, they sustained little damage from a storm that produced lots of damage to other tree species on the site (especially boxelders and silver maples).

Photo 31. Grassland with Sparse Deciduous Trees, Altered. Note the large expanse of mowed turf. Trees in the background are medium-aged boxelders and cottonwoods.
